# Manhole Inspection Summary

Manhole # S23E1\_009MH

Insp Date: **7/22/08 8:38 AM**

**Location** Address: **2622 Hollins Ferry RD**

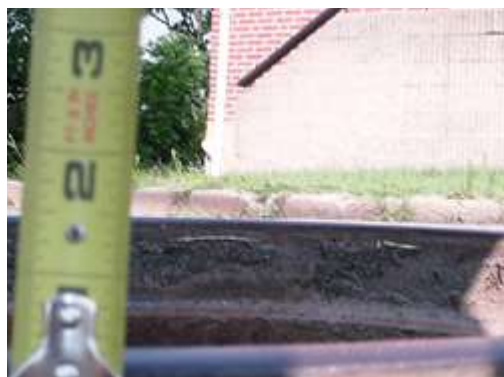
Defect 1

cover to grade .25 inch

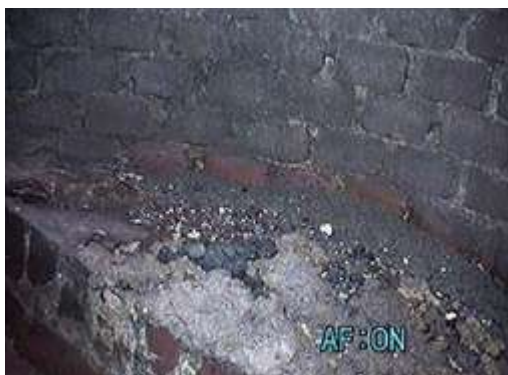
Misc

debris on bench

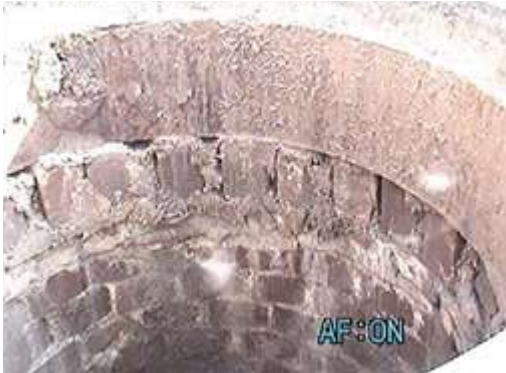
Defect 2

Condition: ☐ Sound ☐ Cracked ☒ **Leaks**

Condition: ☐ Sound ☐ Cracked ☐ Root Intrusion ☐ Loose Brick ☒ **Deteriorated**

Infiltration: ☐ None ☒ **Joint** ☐ Cracks ☒ **Mortar** ☐ Roots ☐ Wall

frame infiltration at cover, chimney deterioratd and infiltration at frame joint and mortar

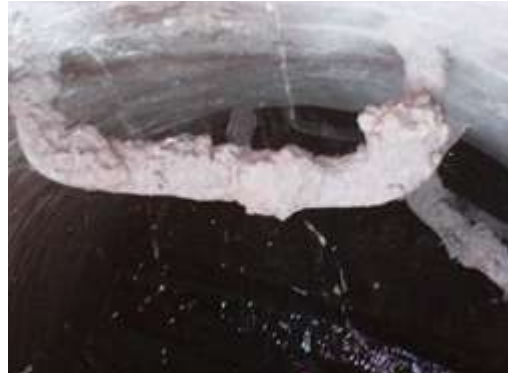
Defect 3

Count: **5** Missing: **0** ☒ **Corroded**

steps corroded

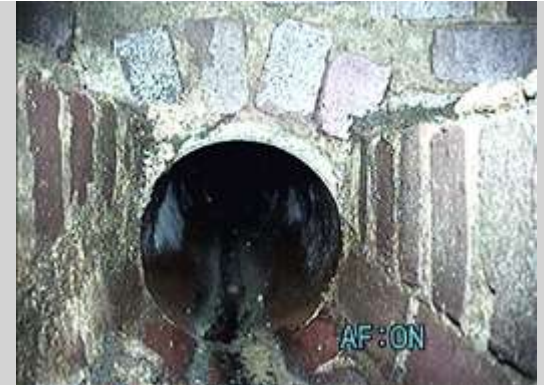
12 O'Clock Outflow

Pipe Height: **8.4** (in.) Rod and Bar (Angled)  
Pipe Material: **Clay** ☐ Pipe Lined  
Invert Depth: **9.74** (ft.) Flow Characteristics: **Slow**  
Deposits: ☒ None ☐ Mud ☐ Sludge ☐ Debris ☐ Grease  
Silt Depth: **0** (in.) Deposits Extent:  
Infiltration: **None** Pipe Seal Cond: **Sound**

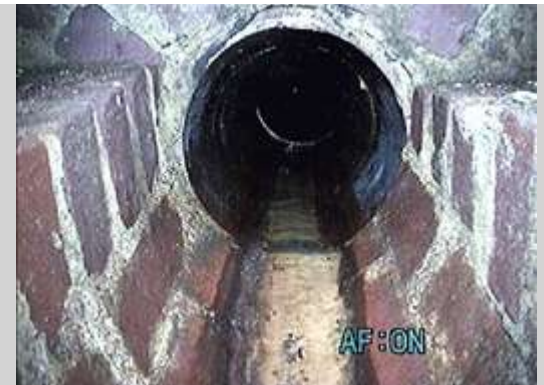
6 O'Clock Inflow

Pipe Height: **8.4** (in.) Rod and Bar (Angled)  
Pipe Material: **Clay** ☐ Pipe Lined  
Invert Depth: **9.39** (ft.) Flow Characteristics: **Slow**  
Deposits: ☒ None ☐ Mud ☐ Sludge ☐ Debris ☐ Grease  
Silt Depth: **0** (in.) Deposits Extent:  
Infiltration: **None** Pipe Seal Cond: **Sound**

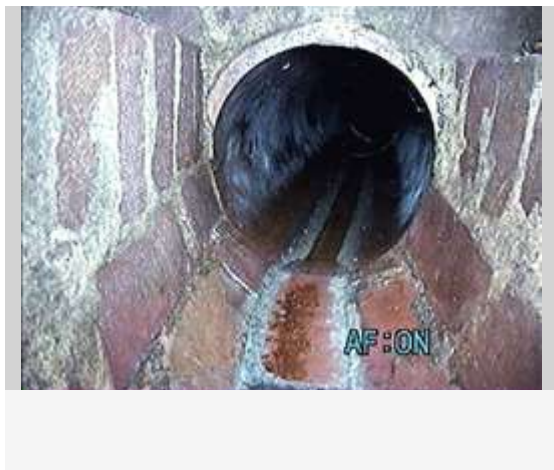
8 O'Clock Inflow

Pipe Height: **8.4** (in.) Rod and Bar (Angled)

Pipe Material: **Clay** ☐ Pipe Lined

Invert Depth: **9.34** (ft.) Flow Characteristics: **Slow**

Deposits: ☒ None ☐ Mud ☐ Sludge ☐ Debris ☐ Grease

Silt Depth: **0** (in.) Deposits Extent:

Infiltration: **None** Pipe Seal Cond: **Sound**
